# Spontaneous Glass Break?

## Thermal Stress Crack

## Toughened Glass Explosion

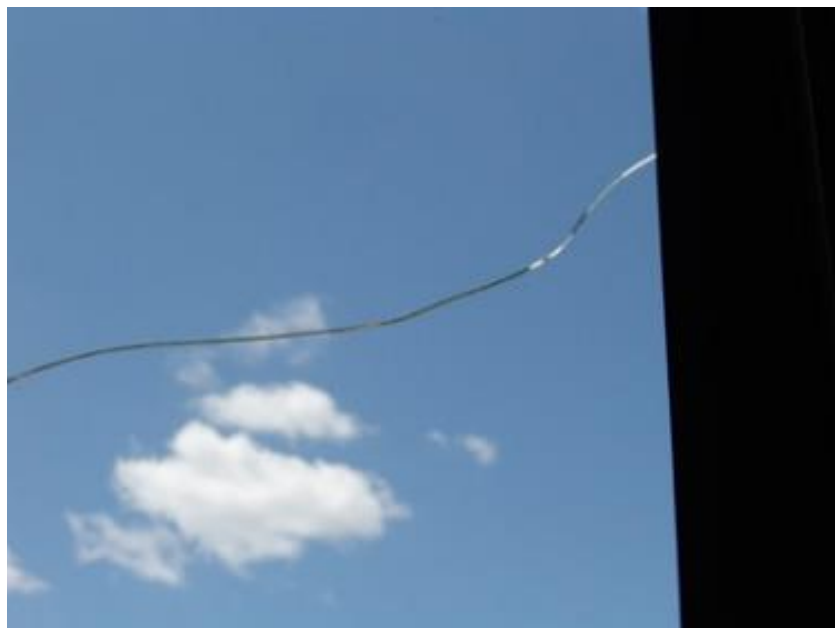
Rapid temperature changes are the primary cause of thermal stress cracks in windows. If the temperature outside is significantly different from the temperature inside, the glass may not be able to adjust to the changes, leading to cracks.

Ensure glass edge have an arris or polished edge to prevent stress occurring.  
Ensure that your windows are properly installed and have enough room to expand and contract.

Unlike the window being at direct impact, stress cracks seem to appear out of nowhere.

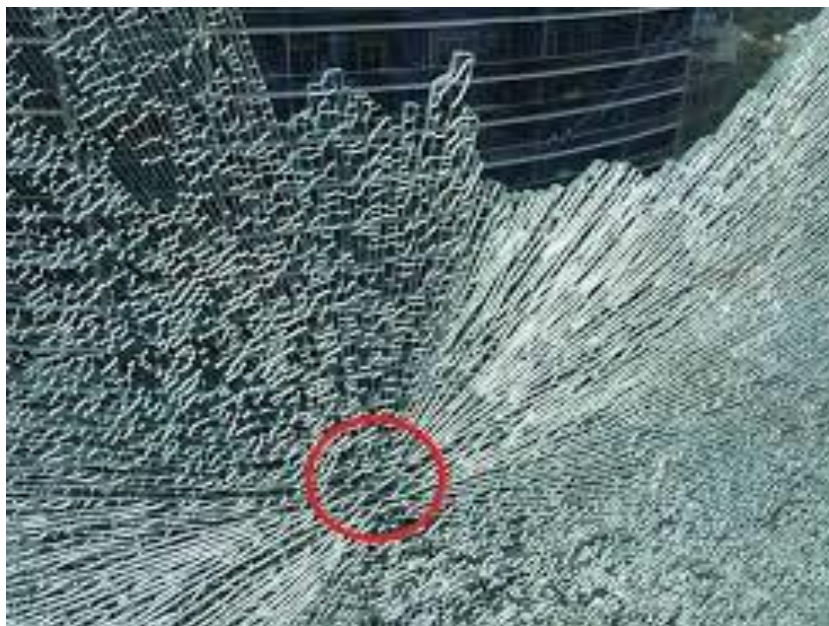
Implosion caused by nickel sulphide inclusion will centre around a singular point flanked by two pentagonal or octagonal-shaped fragments. If the destruction wasn't so frustrating, its pattern would be very pretty, and is often compared with a butterfly or a figure-of-eight. The nickel sulphide stone will be tiny, measuring between 0.06 and 0.5 millimetres and often only visible under an electron microscope. Identification of nickel sulphide inclusion breakages is often made trickier by the fact that the pane of glass could be in a thousand pieces on the floor.

**One key reason toughened safety glass breaks is due to nickel sulphide inclusion.**
